# Addendum No. 01

## PORTERVILLE COLLEGE FINE ARTS DARK ROOM

**ASBESTOS SURVEY  
PORTERVILLE COLLEGE VIDEO EDITING ROOM  
100 EAST COLLEGE AVENUE  
PORTERVILLE, CALIFORNIA**

**LEAD-BASED PAINT SURVEY  
PORTERVILLE COLLEGE VIDEO EDITING ROOM  
100 EAST COLLEGE AVENUE  
PORTERVILLE, CALIFORNIA**

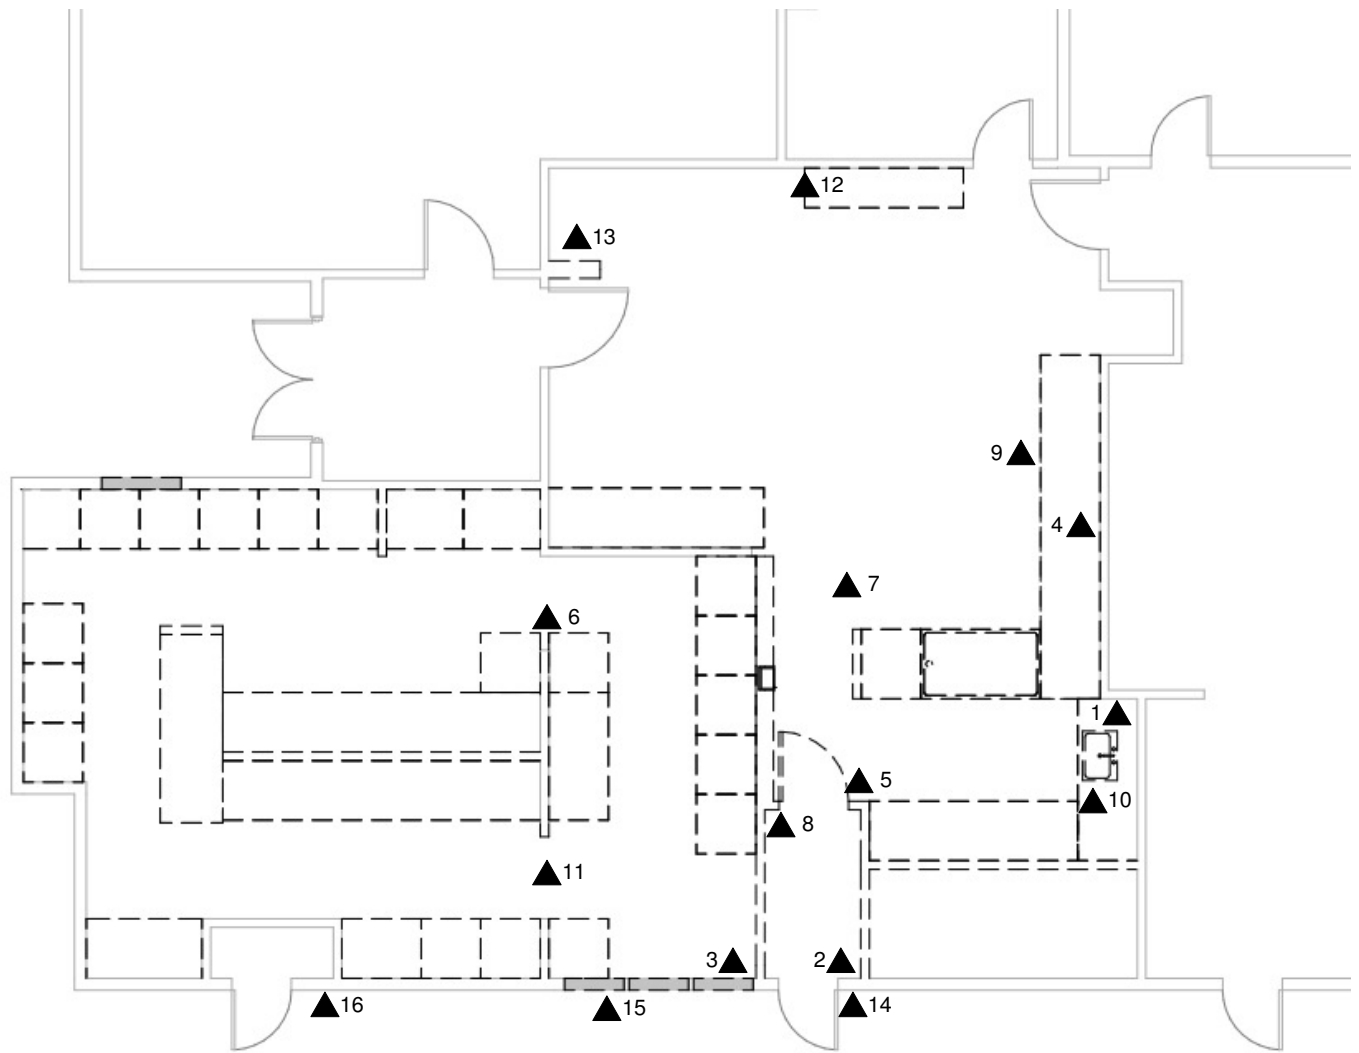
Figure No.  
1

No samples collected from this structure contained detectable amounts of asbestos.

**FLOOR PLAN WITH BUILDING MATERIAL  
SAMPLE LOCATIONS**

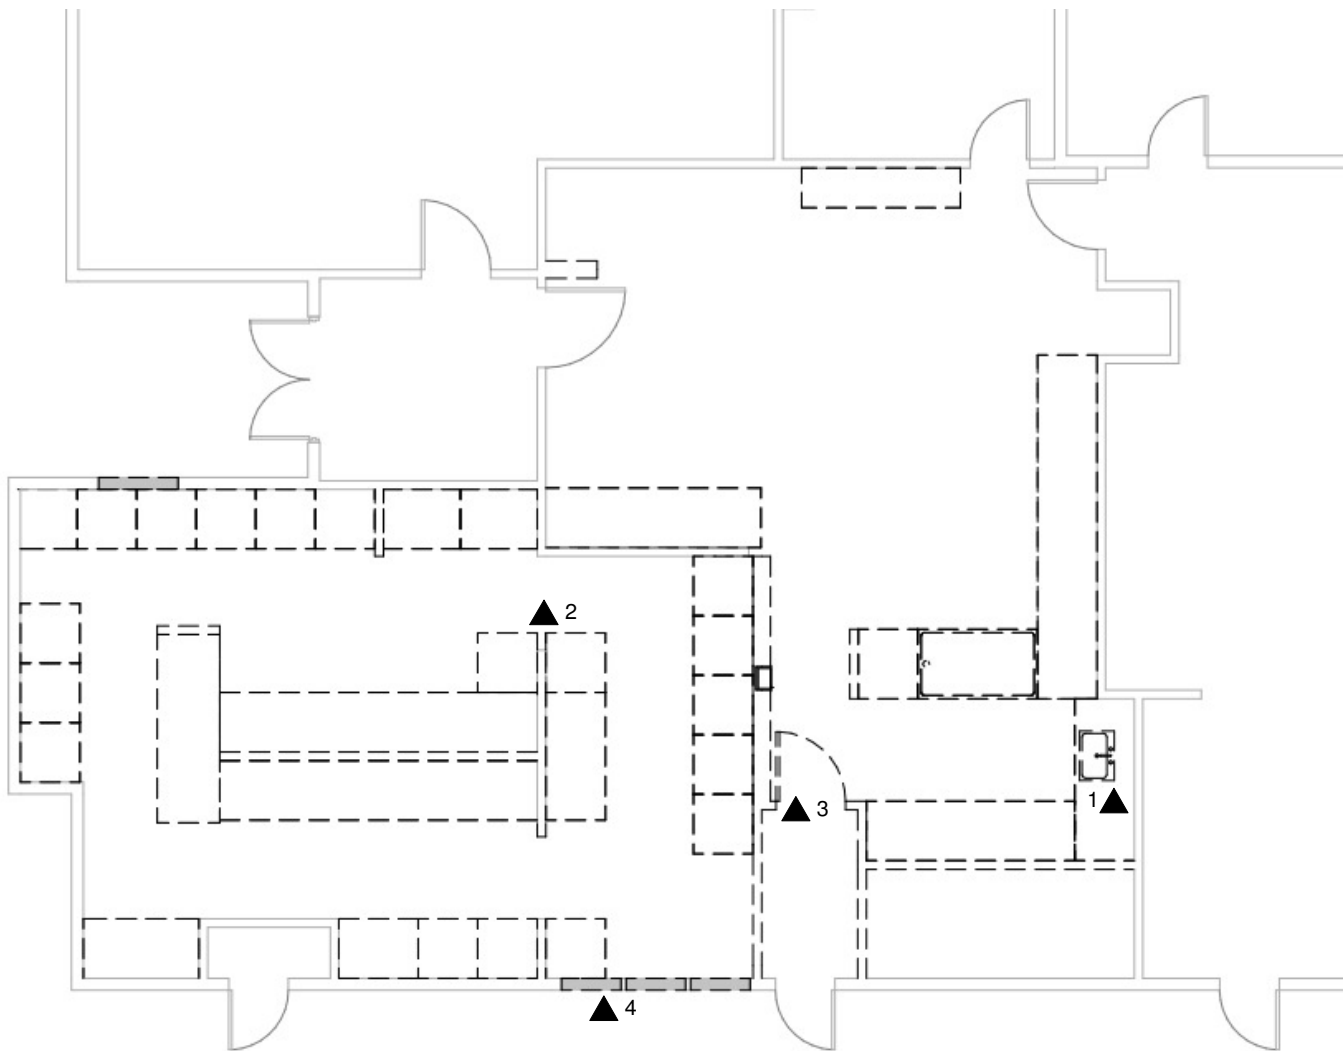
Figure No.  
1

No paints associated with the structure contained 0.5% or greater total lead by weight.

No paints associated with the structure contained greater than 0.009% total lead by weight.

The paints on the exterior and interior of the structure surveyed were generally in good condition.

**FLOOR PLAN WITH BUILDING MATERIAL  
SAMPLE LOCATIONS**
