Addendum No. 02

PORTERVILLE COLLEGE CAREER CENTER

**ASBESTOS SURVEY
PORTERVILLE COLLEGE CAREER CENTER
100 EAST COLLEGE AVENUE
PORTERVILLE, CALIFORNIA**

**LEAD-BASED PAINT SURVEY
PORTERVILLE COLLEGE CAREER CENTER
100 EAST COLLEGE AVENUE
PORTERVILLE, CALIFORNIA**

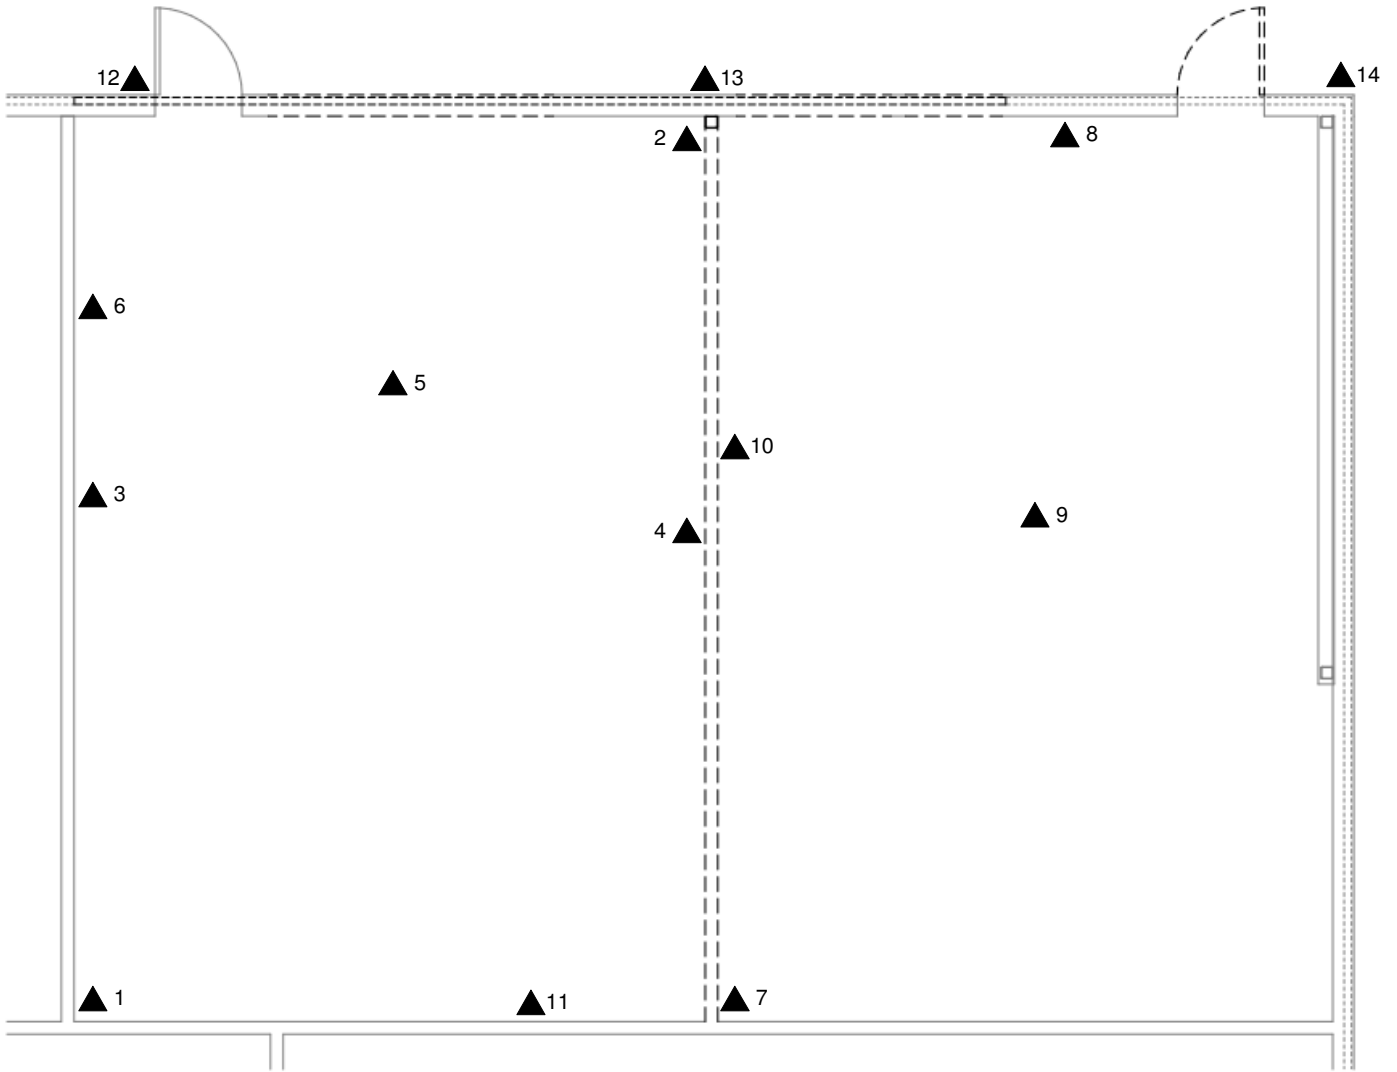
Figure No.
1

No samples collected from this structure contained detectable amounts of asbestos.

**FLOOR PLAN WITH BUILDING MATERIAL
SAMPLE LOCATIONS**

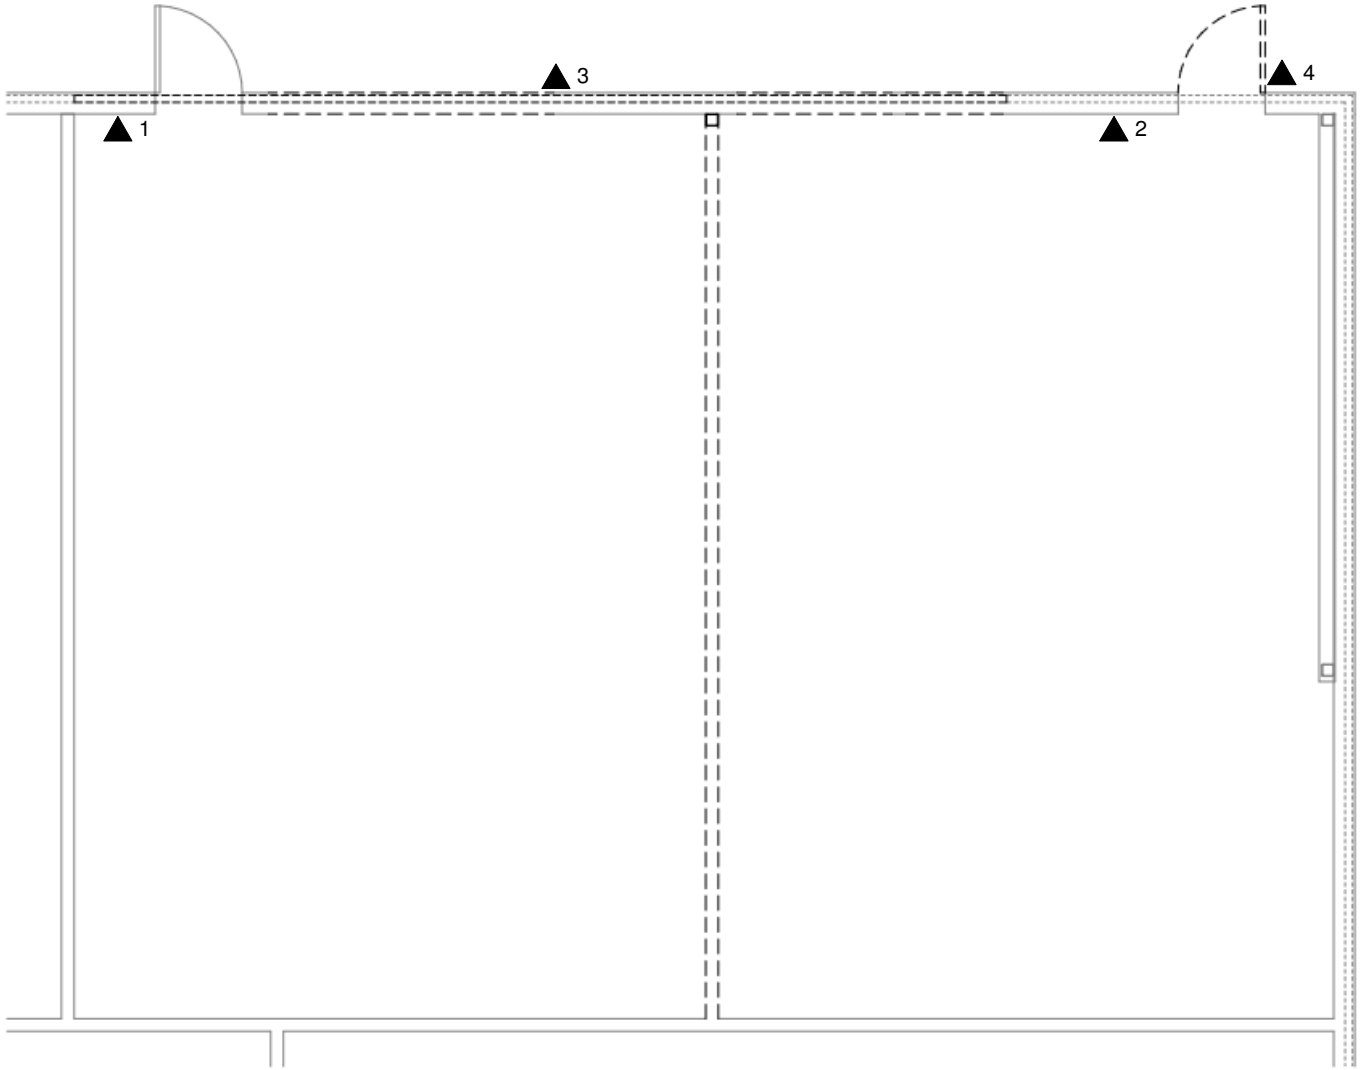
Scale: NOT TO SCALE	Date: 10 / 23
Drawn by: J. R. N.	Approved by: J.R.N
Project No. 014-23116	Figure No. 1

Brown metal door frame – exterior (Sample No. 4)

FLOOR PLAN WITH
 PAINT SAMPLE LOCATIONS
 PORTERVILLE COLLEGE
 CAREER CENTER
 100 EAST COLLEGE AVENUE
 PORTERVILLE, CALIFORNIA
